# Manhole Inspection Summary

Manhole # S39EE\_019MH

Insp Date: **1/13/08 3:27 PM**

**Location** Address: **1107 WILLINGER CT**

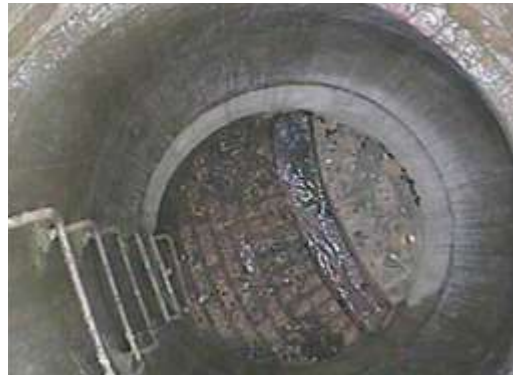
Top View

Condition: **Cracked**

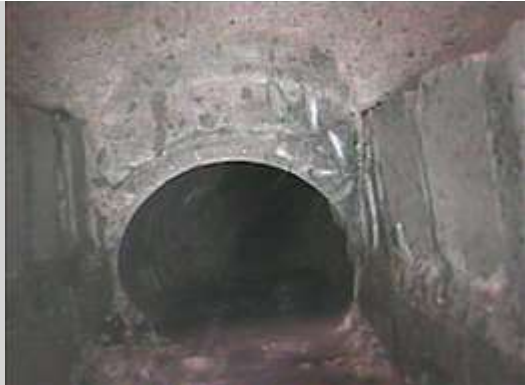
12 O'Clock Outflow

8 in. Circular Gravity Sewer  
Pipe Out @ 12 O'Clock

Pipe Material: **Clay** ☐ Pipe Lined

Invert Depth: **9.90** (ft.) Flow Characteristics: **Slow**

Deposits: ☒ None ☐ Mud ☐ Sludge ☐ Debris ☐ Grease

Infiltration: **None** Pipe Seal Cond: **Sound**

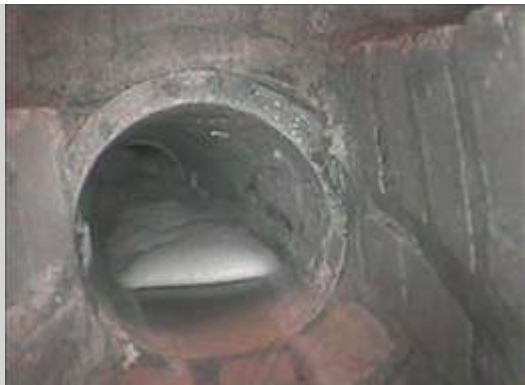
5 O'Clock Inflow

8 in. Circular Gravity Sewer  
Pipe In @ 5 O'Clock

Pipe Material: **Clay** ☐ Pipe Lined

Invert Depth: **9.81** (ft.) Flow Characteristics: **Slow**

Deposits: ☒ None ☐ Mud ☐ Sludge ☐ Debris ☐ Grease

Infiltration: **None** Pipe Seal Cond: **Sound**
